# Hazardous Building Materials Survey

Survey Date - 18 March 2020

Watts Peninsula - Farm Buildings

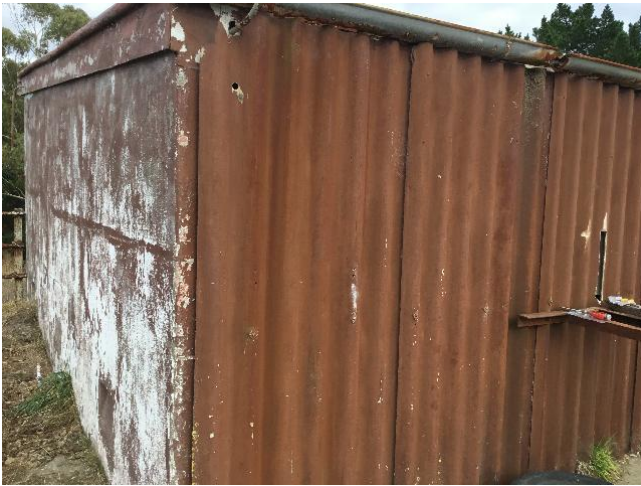
Sample/Observation Reference: **B02**

NON-FRIABLE ACM CLASS B REMOVAL			
Sample/ Observation	Material Description	Apx Qty m <sup>2</sup>	Analytical Result/Field Observation
B02	Cement sheet cladding on exterior wall Small Barn	4.50	Chrysotile and amosite asbestos present
A01	Flashing Small Barn	9.60	Assumed Asbestos

Cement sheet cladding on exterior wall Small Barn  
**Chrysotile and amosite asbestos** (laboratory result)

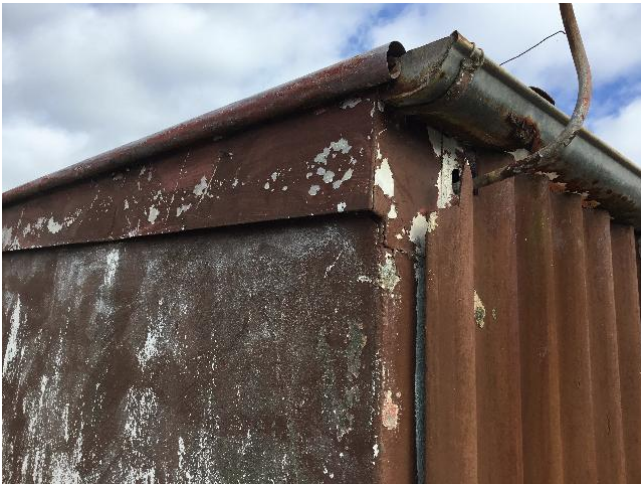
Sample/Observation Reference: **B03**

Hazardous Building Materials			
Sample/ Observation	Material Description	Apx Qty m <sup>2</sup>	Analytical Result/Field Observation
B01	Big Barn exterior paint	144	3.53 % lead
B03	Small Barn exterior paint	80	17.6 % lead
B04	Small Barn internal paint	85	7.46 % lead

Exterior paint Small Barn  
External paint – 17.6 % lead (laboratory result)

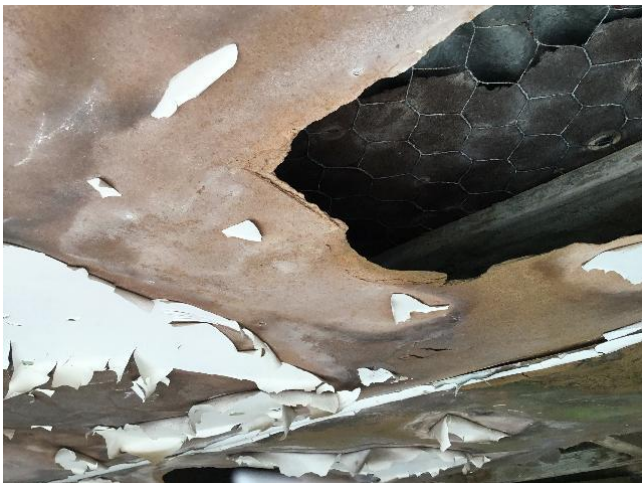
No ACM Assumed (wood fibre)

Small Barn interior ceiling and lining paper

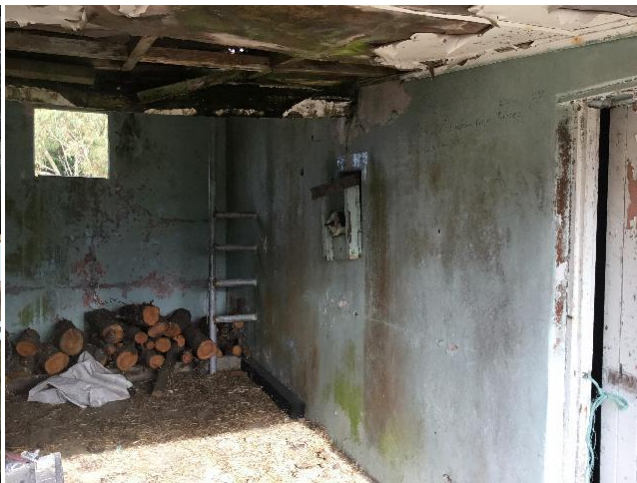
Sample/Observation Reference: **B04**

Small Barn Interior paints – 7.46 % lead (laboratory result)

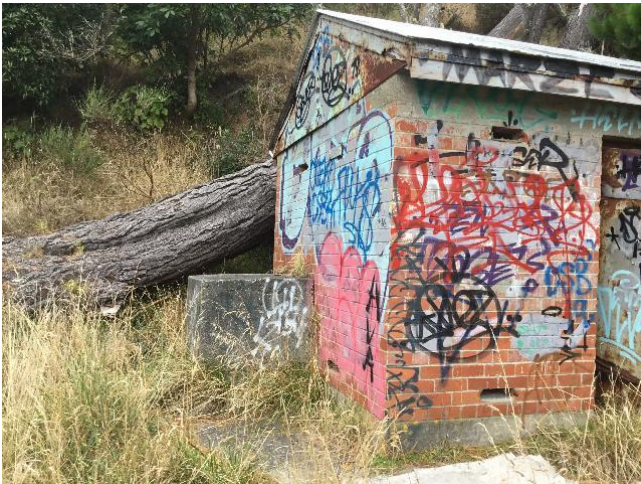
Left side (note concrete box at base of wall)

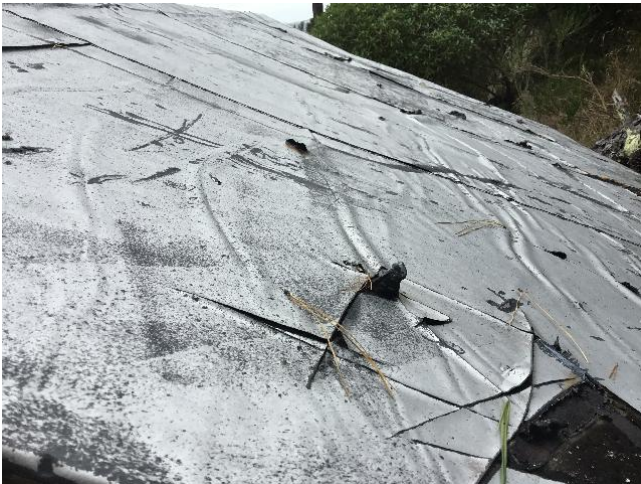
Sample/Observation Reference: **B01**

Black bitumen fabric on roof

No asbestos detected (laboratory result)

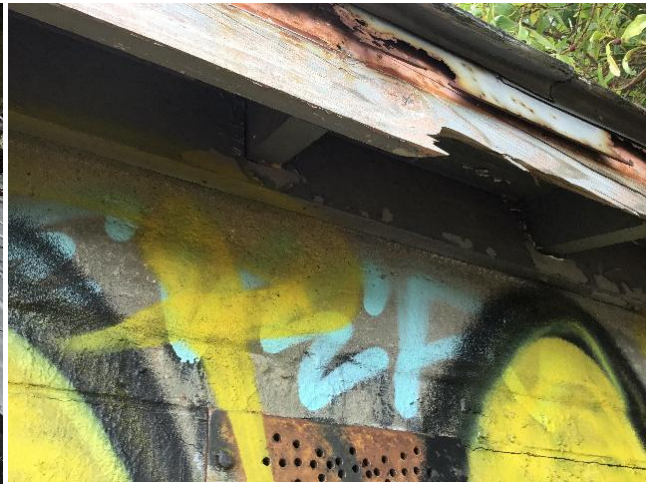
Sample/Observation Reference: **B02**

External paints

0.02% lead (laboratory result)

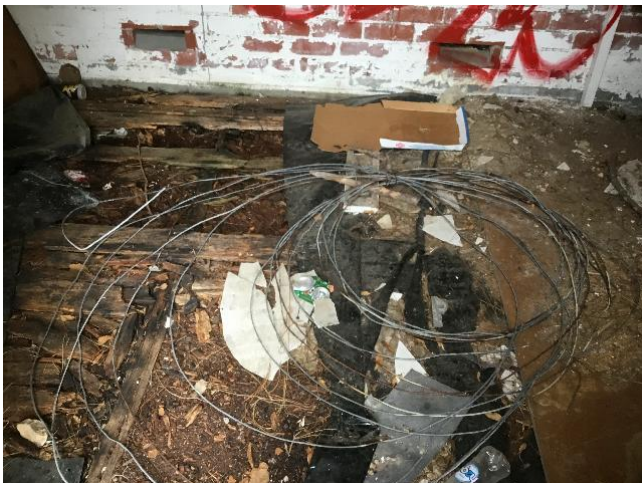
Sample/Observation Reference: **B03**  
Ceiling cement sheet and debris on floor  
**Chrysotile asbestos** (laboratory result)

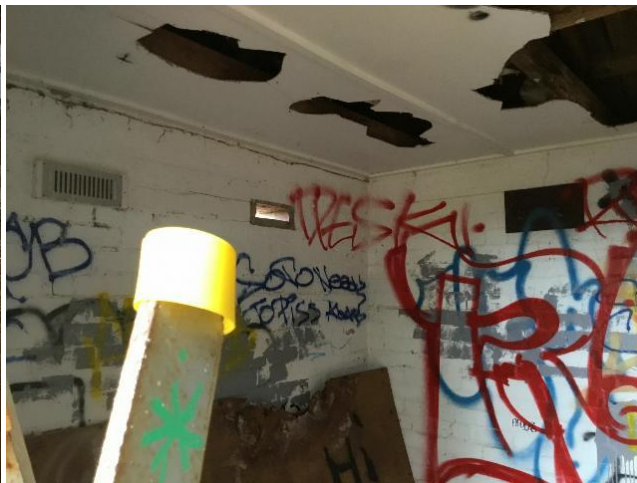
Sample/Observation Reference: **B04**  
Internal paint – 0.24% lead (laboratory result)

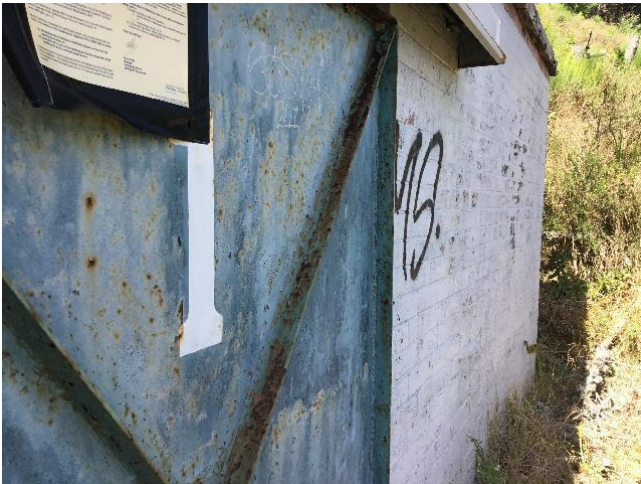
Exterior paint to door and walls

Lead 0.05% (laboratory result)

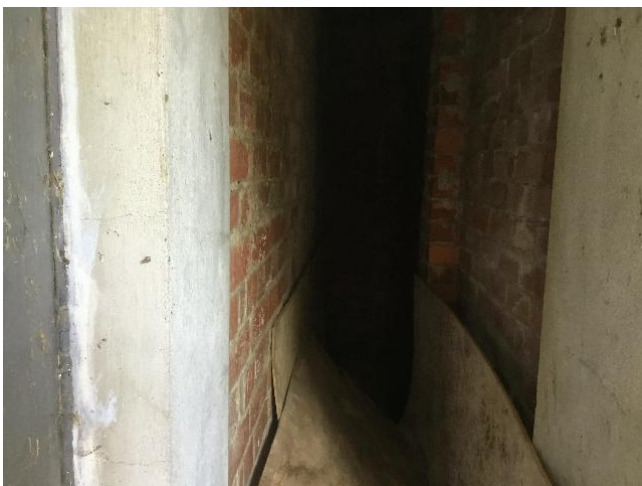
Sample/Observation Reference: **A01**

Assumed ACM

Internal wall/External wall (blast cavity)

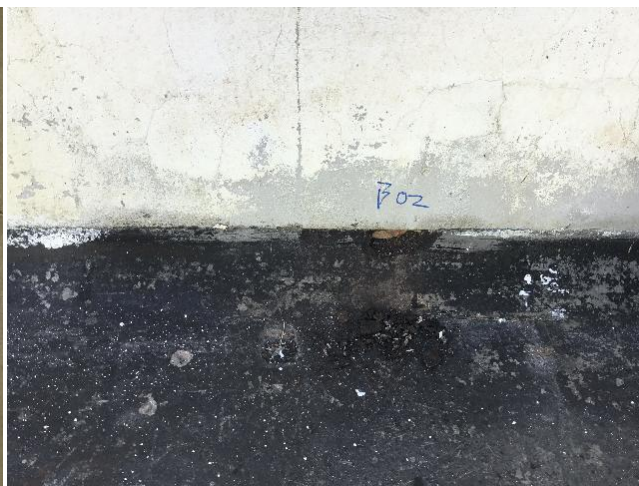
Sample/Observation Reference: **B02 + A02**

Black bitumen flooring material

**Chrysotile asbestos** (laboratory result)

Assumed PAHs

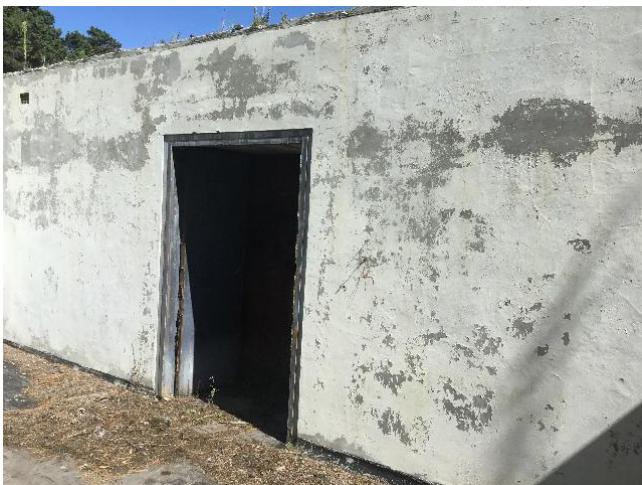
Sample/Observation Reference: **B03**

Internal paint

Lead 0.15% (laboratory result)

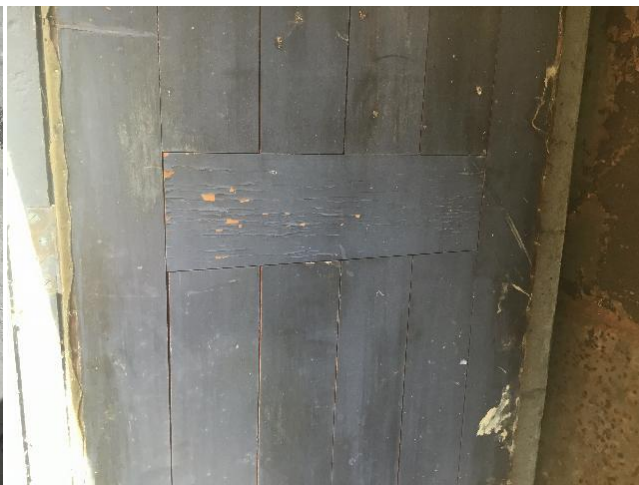
Sample/Observation Reference: **B04**

Blue grey paint internal doors

Lead 9.45% (laboratory result)

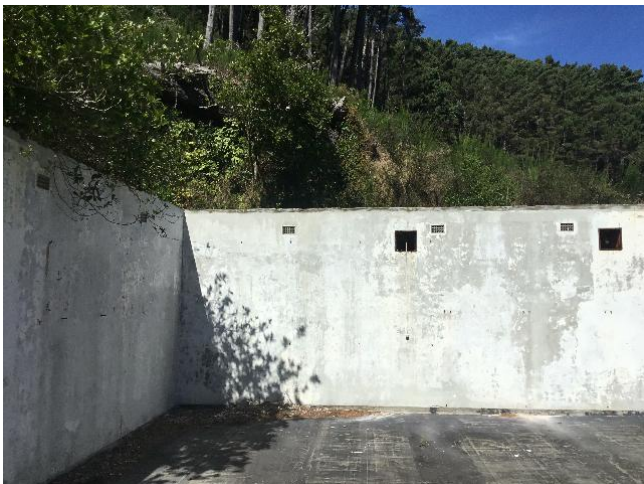
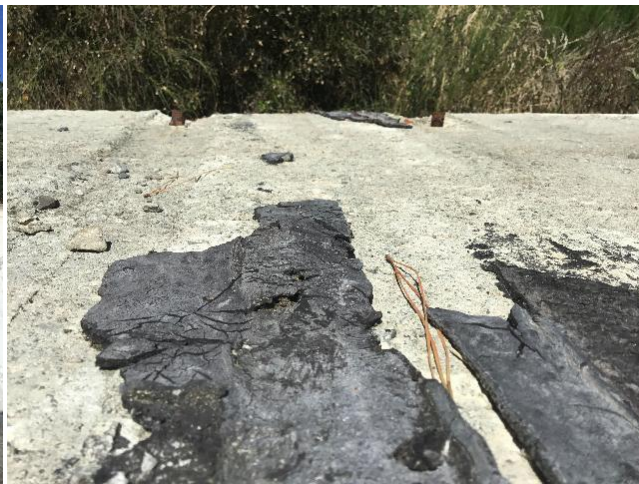
Black bitumen material on top of wall

**Chrysotile asbestos** (laboratory result)

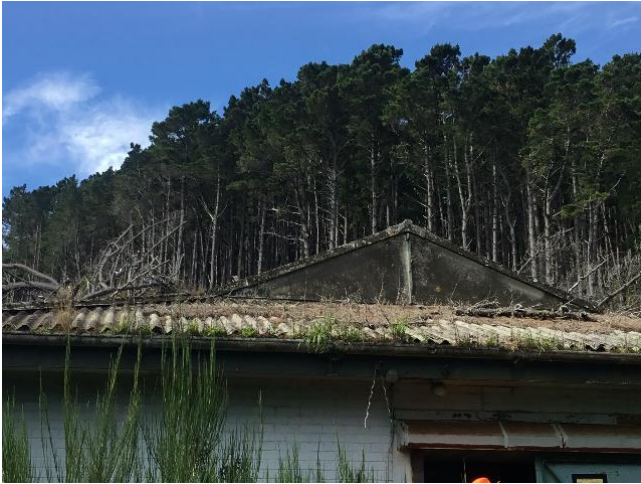
Assumed ACM

Roof, and gable materials (cement sheet materials)

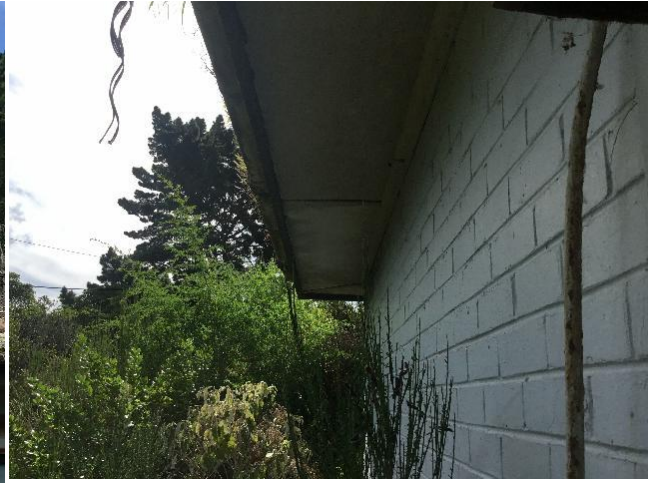
Sample/Observation Reference: **A04**

Assumed ACM

Soffits

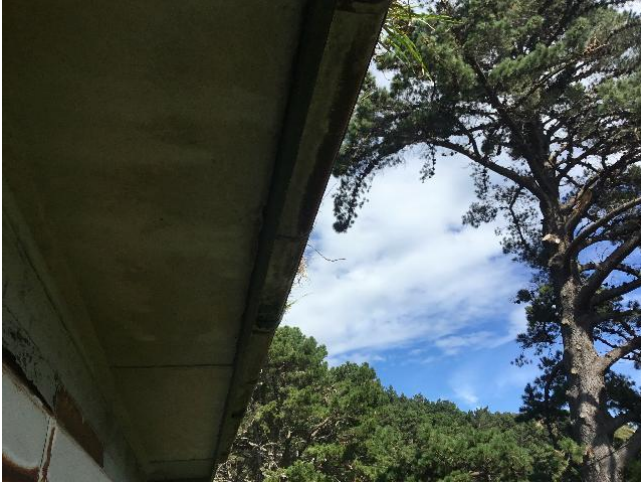
Sample/Observation Reference: **B05**

Guttering

**Chrysotile asbestos** (laboratory result)

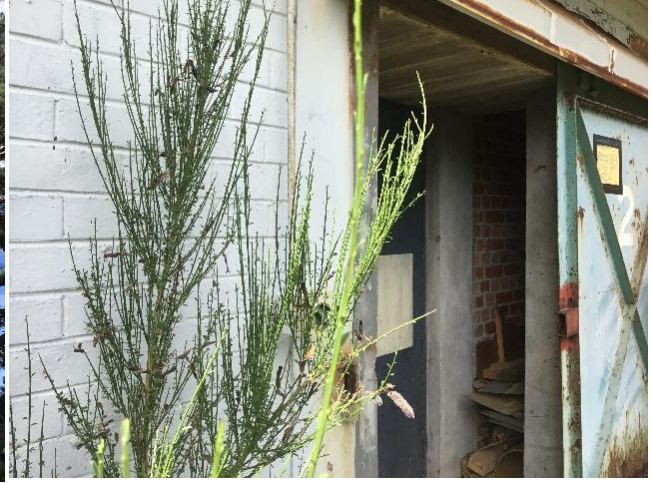
Sample/Observation Reference: **B06**

Exterior paints

0.41 % lead (laboratory result)

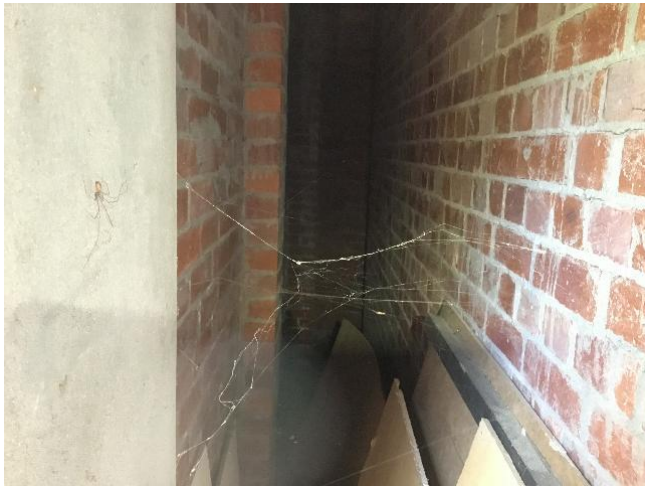
Sample/Observation Reference: **A02**

Assumed ACM

Internal wall (blast cavity)

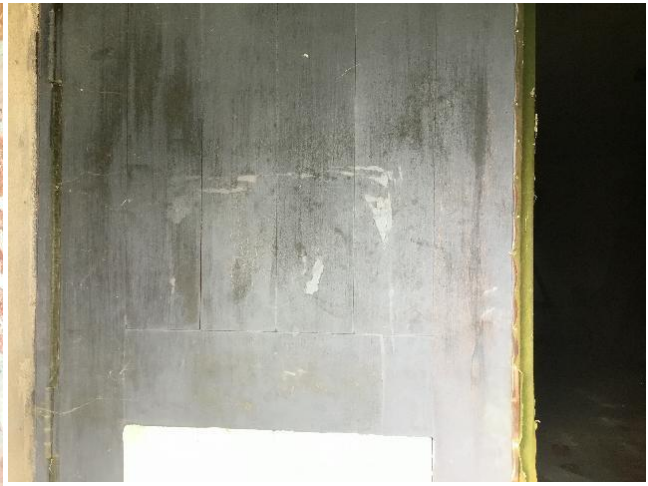
Sample/Observation Reference: **A03**

Assumed lead paint

Internal doors blue grey paint

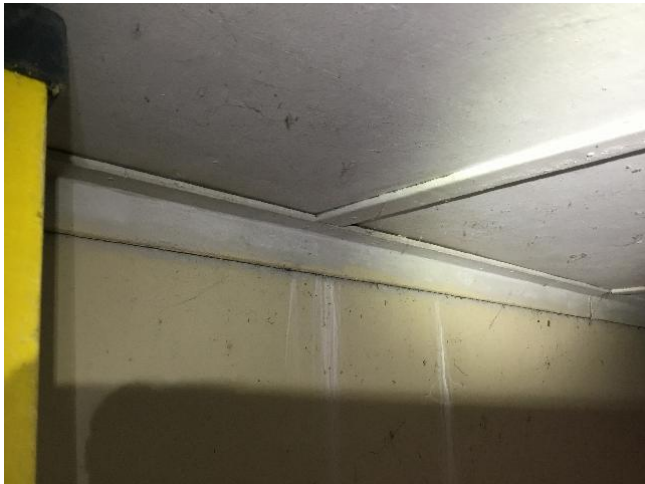
Sample/Observation Reference: **B03**

Wall to ceiling coving detail

**Chrysotile asbestos** (laboratory result)

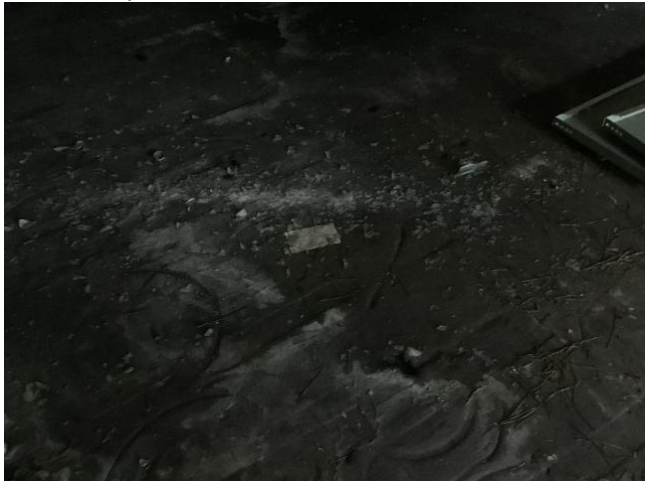
Debris on floor below broken light tubes

48.9 mg mercury, < laboratory detection limits for PCB

(laboratory results)

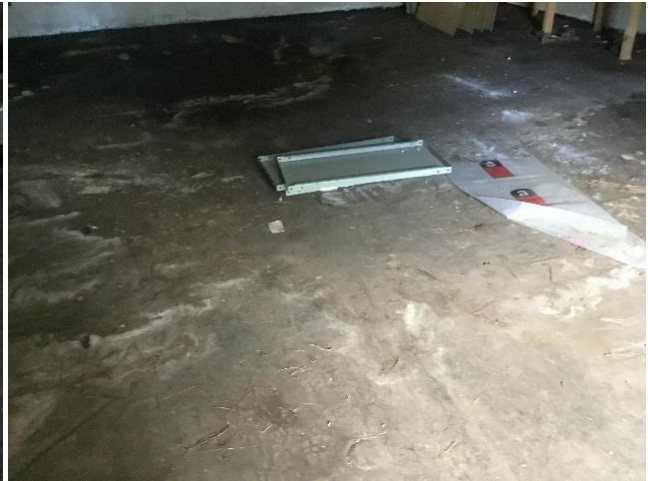
Sample/Observation Reference: **A01 + A04**

Assumed ACM

Assumed PAHs

Bitumen flooring

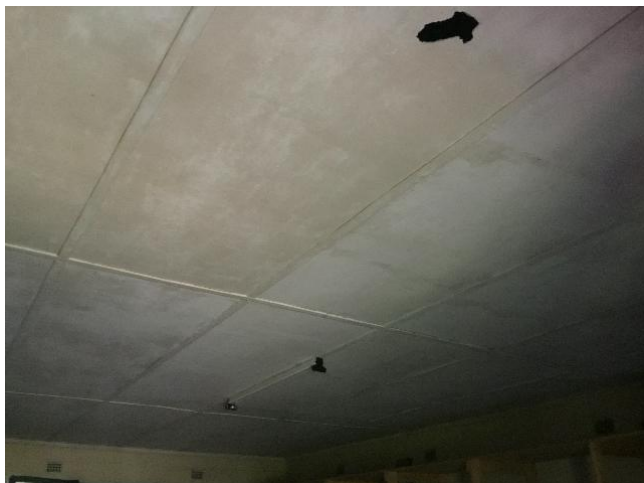
Sample/Observation Reference: **B01**  
Internal ceiling cement sheet  
**Chrysotile asbestos** (laboratory result)

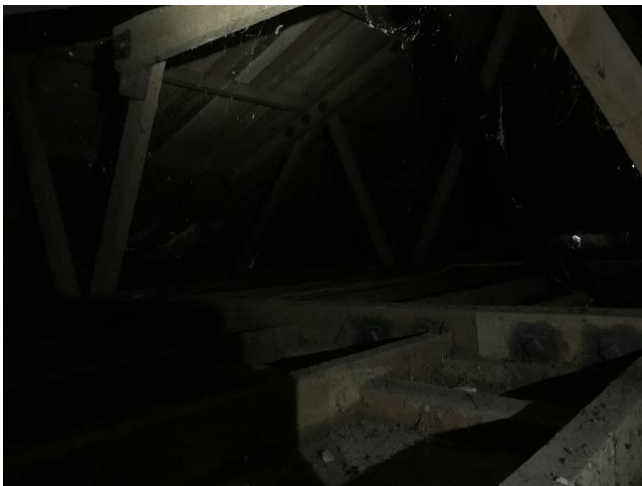
Assumed ACM

Attic (viewed from access hatch)

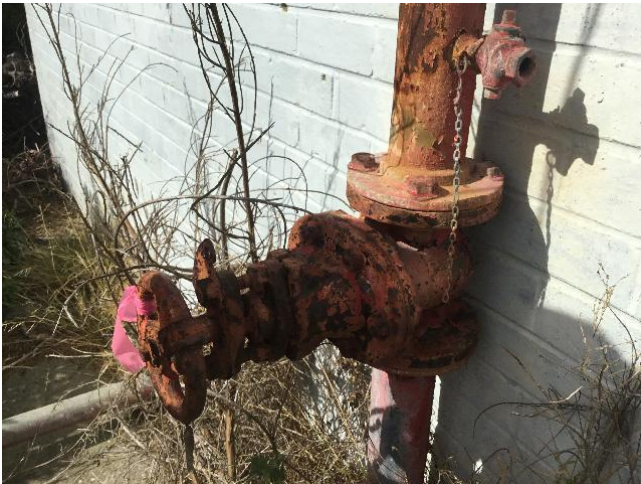
Sample/Observation Reference: **B02**  
Red paint to fire riser  
21.6 % lead (laboratory result)

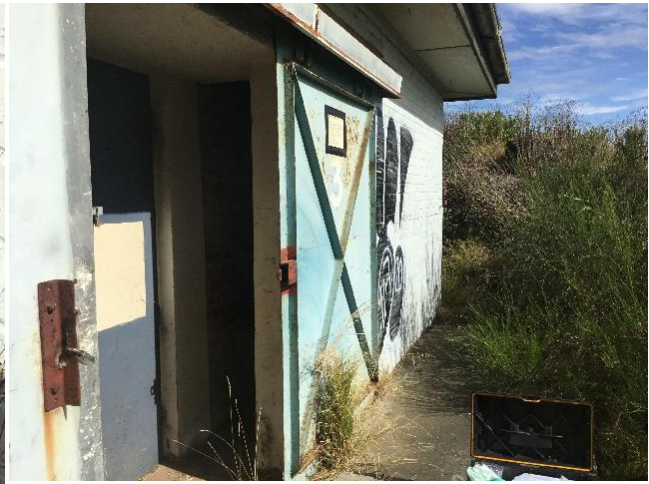
Sample/Observation Reference: **B03**  
Exterior paints  
9.45 % lead (laboratory result)

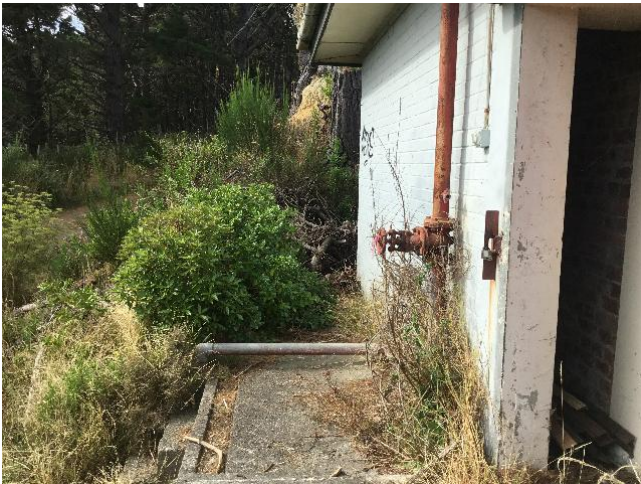
Sample/Observation Reference: **A05**  
Assumed ACM  
Fire water riser (gaskets)

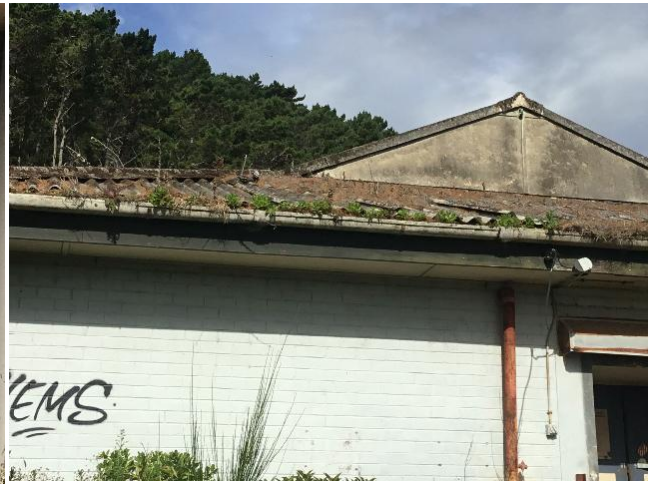
Sample/Observation Reference: **B05**  
Roof and gutters  
**Chrysotile asbestos** (laboratory result)

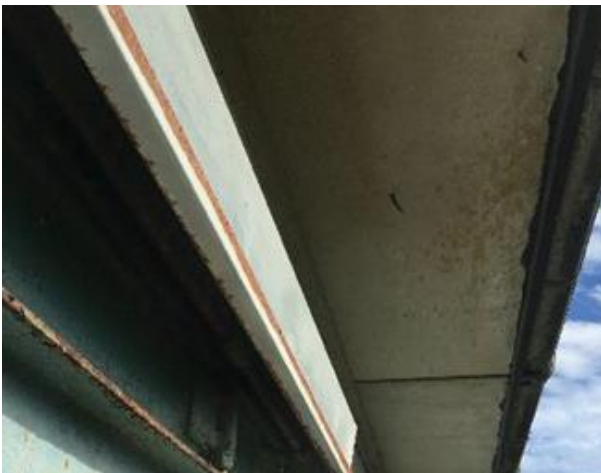
Sample/Observation Reference: **A06**  
Assumed ACM  
Soffits

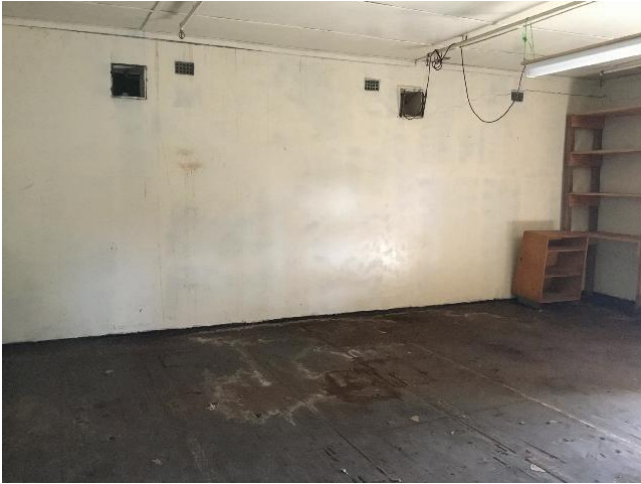
Sample/Observation Reference: **B04**  
Internal paint  
0.02 % lead (laboratory result)

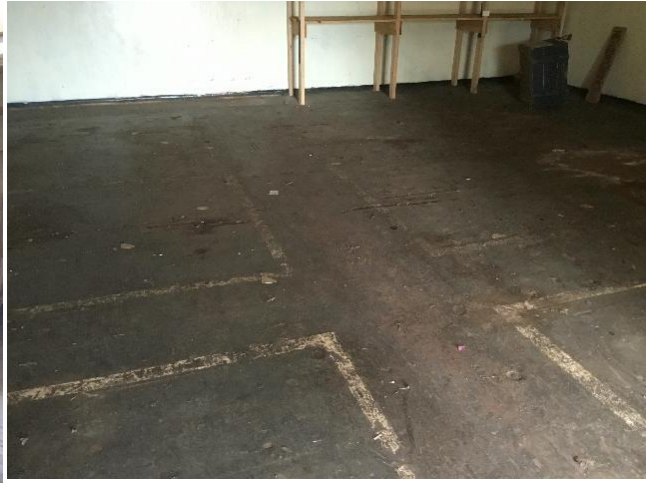
Sample/Observation Reference: **A02**  
Assumed ACM  
Bitumen flooring

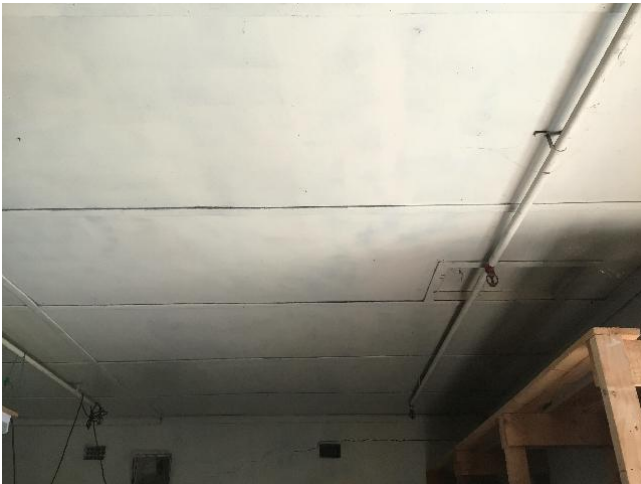
Sample/Observation Reference: **A01**  
Assumed ACM  
Attic

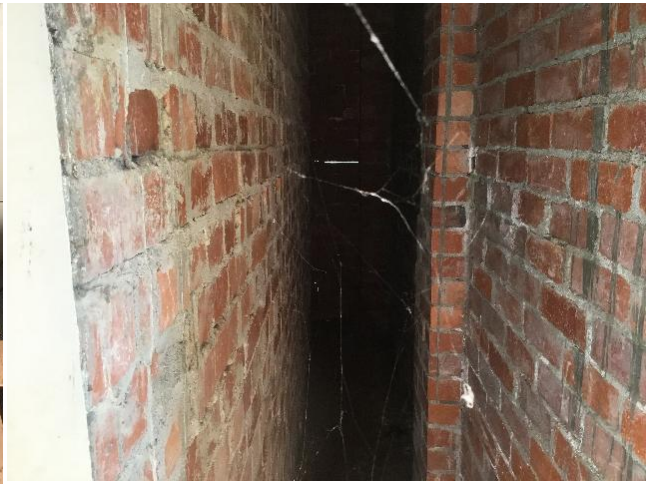
Sample/Observation Reference: **A03**  
Assumed ACM  
Interior wall/exterior wall (blast cavity)

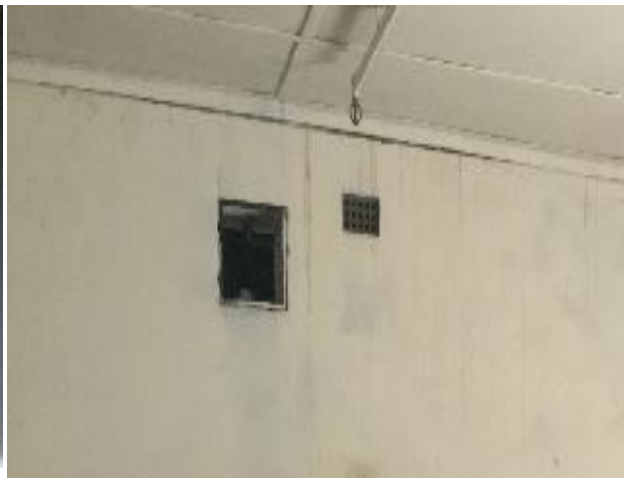
Sample/Observation Reference: **B01**  
Cement sheet ceiling and coving materials  
**Chrysotile asbestos** (laboratory result)

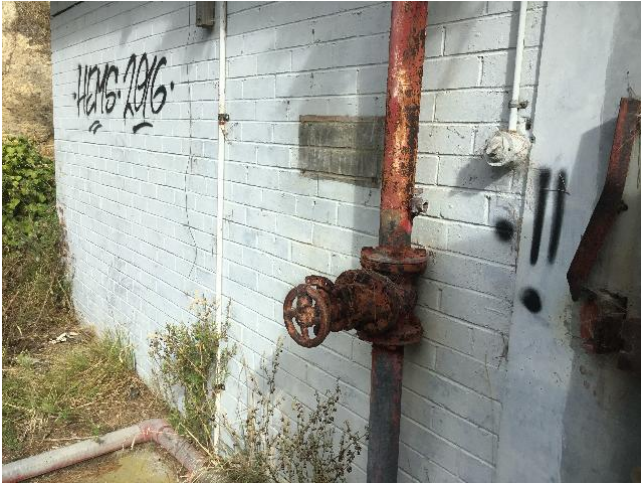
Assumed ACM

Fire riser (gasket)

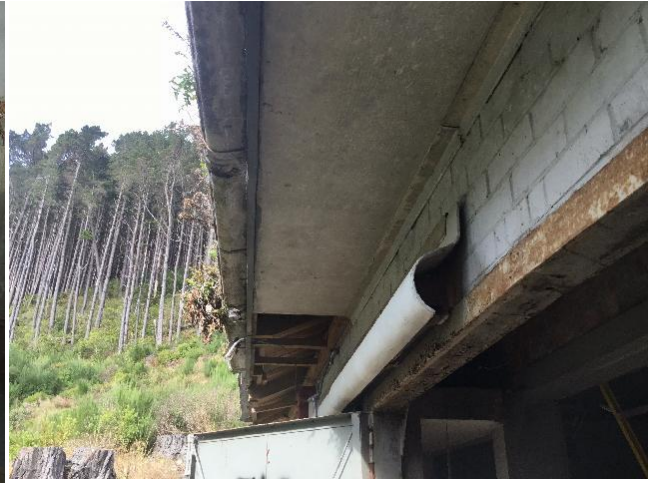
Sample/Observation Reference: **A05**

Assumed ACM

Soffits and flashing over door

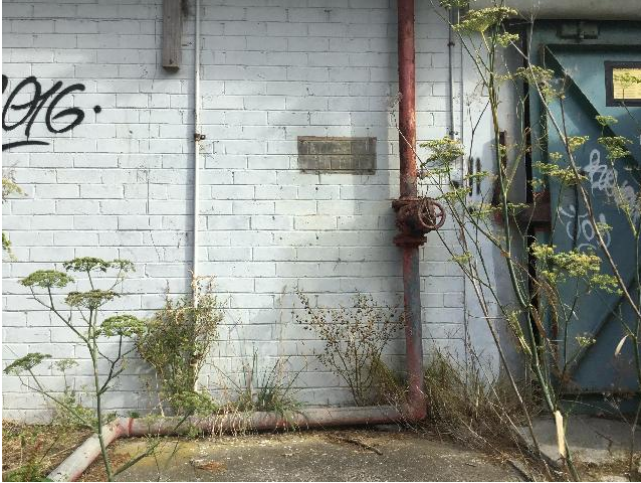
Sample/Observation Reference: **B03**

Exterior paint

11.8 % lead (laboratory result)

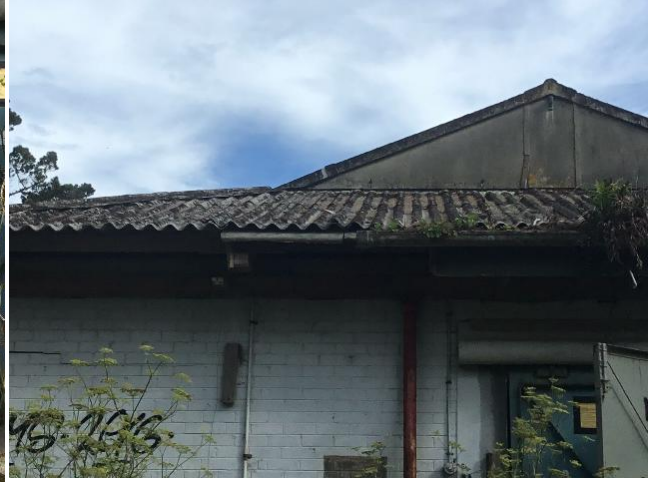
Sample/Observation Reference: **A07**

Assumed ACM

Gutters and roofing

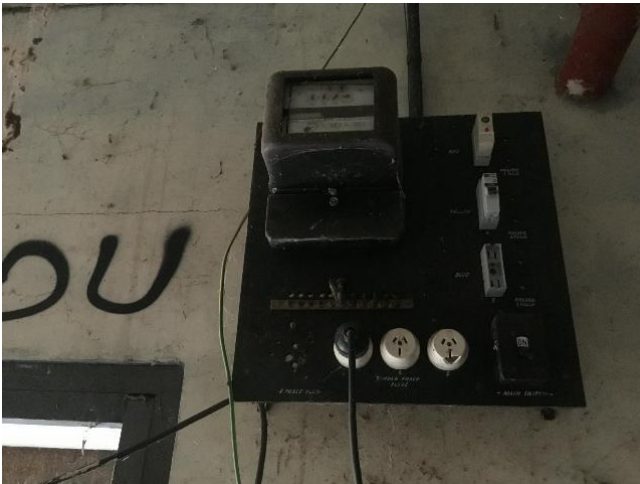
Sample/Observation Reference: **B02**

Switch board

**Chrysotile asbestos present** (laboratory result)

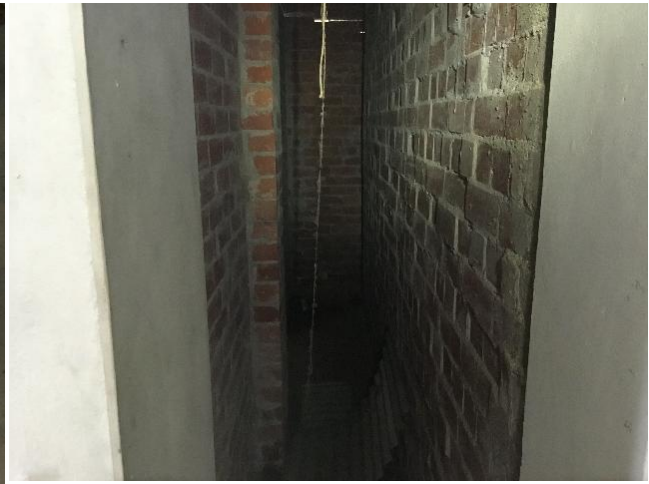
Sample/Observation Reference: **A04**

Assumed ACM

Inside cavity wall

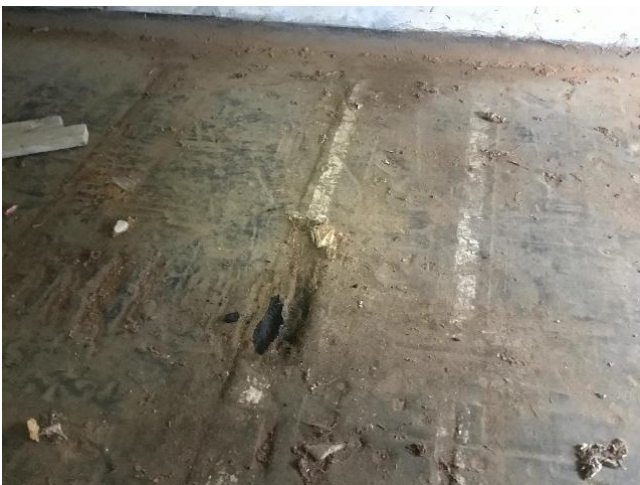
Sample/Observation Reference: **B01 + A08**

Bitumen floor coating

**Chrysotile asbestos present** (laboratory result)

Assumed PAHs

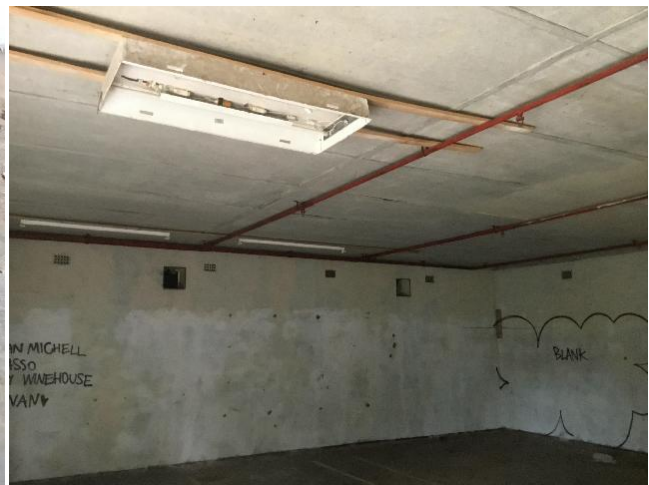
Sample/Observation Reference: **A01**

Assumed ACM

Internal ceiling and coving cement sheet materials

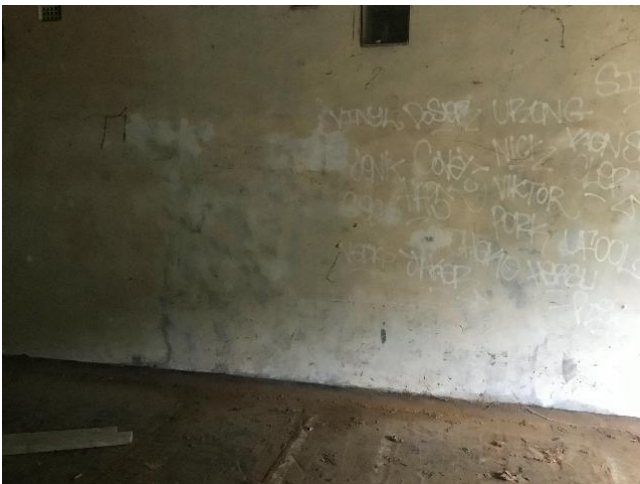
Sample/Observation Reference: **A03**

Paint on walls

Assumed lead paint

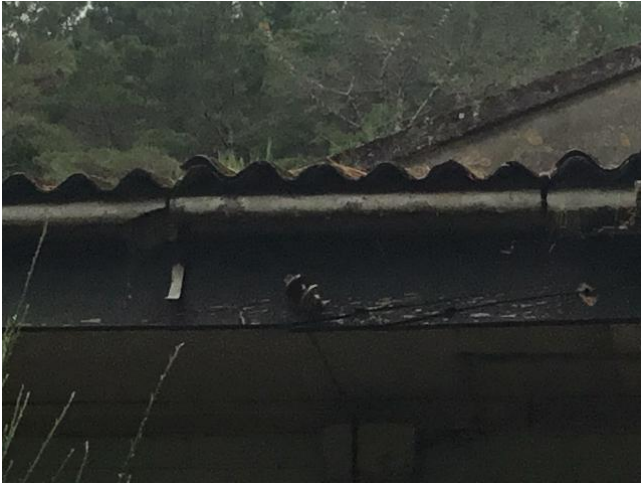
Sample/Observation Reference: **B01**

Super 6 roofing

**Chrysotile asbestos** (laboratory result)

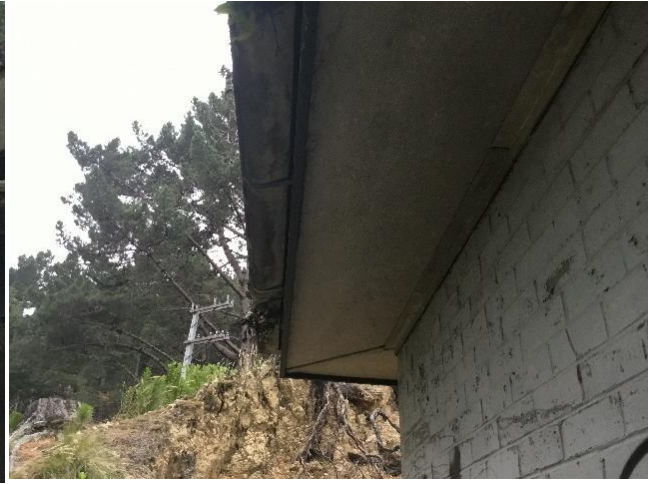
Sample/Observation Reference: **B02**

Soffits

**Chrysotile asbestos** (laboratory result)

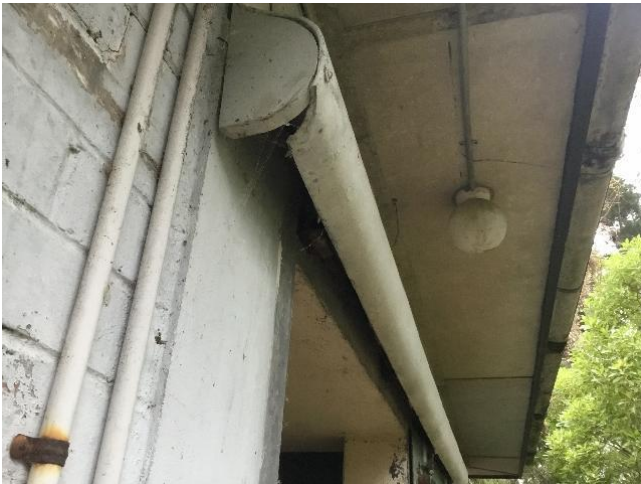
Sample/Observation Reference: **A01**

**Assumed ACM**

Flashing over door

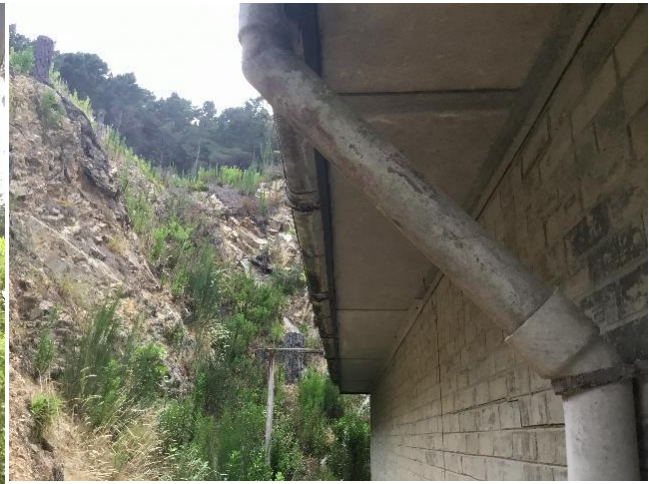
Sample/Observation Reference: **B03**

Gutters and downpipes

**Chrysotile asbestos** (laboratory result)

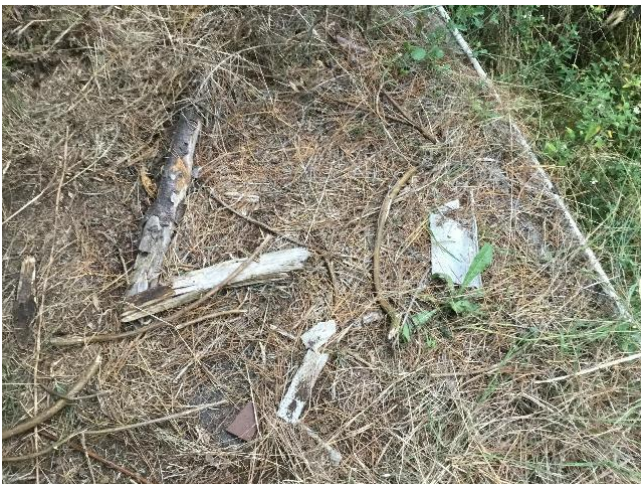
Sample/Observation Reference: **A02**

**Assumed ACM**

Cement sheet debris on floor in front door  
(guttering)

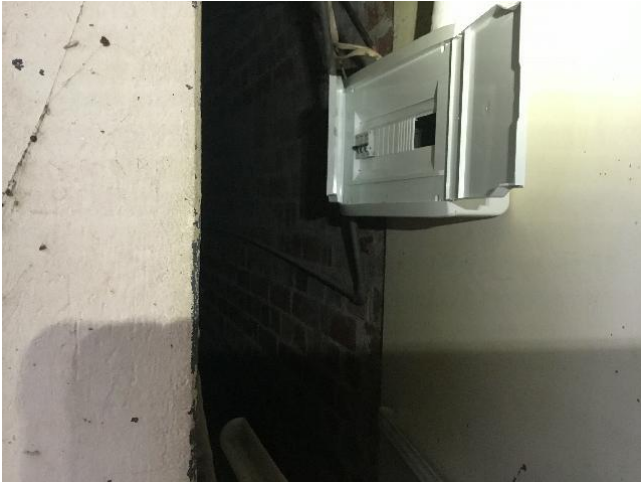
Sample/Observation Reference: **N01**  
No ACM Assumed  
Modern electric board

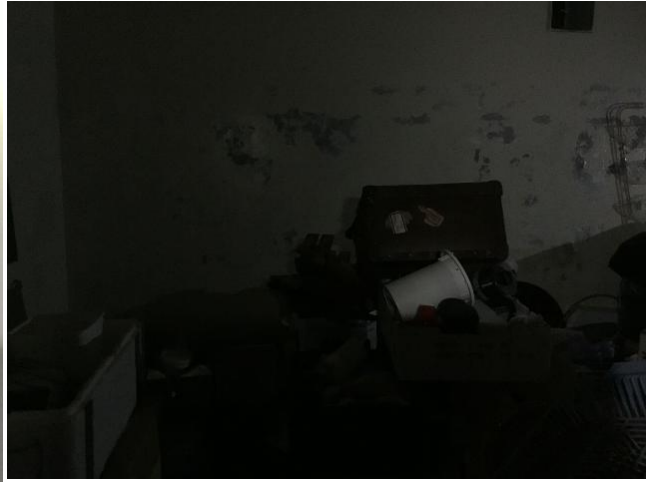
Sample/Observation Reference: **B04**  
Paint on walls  
0.6 % lead (laboratory result)

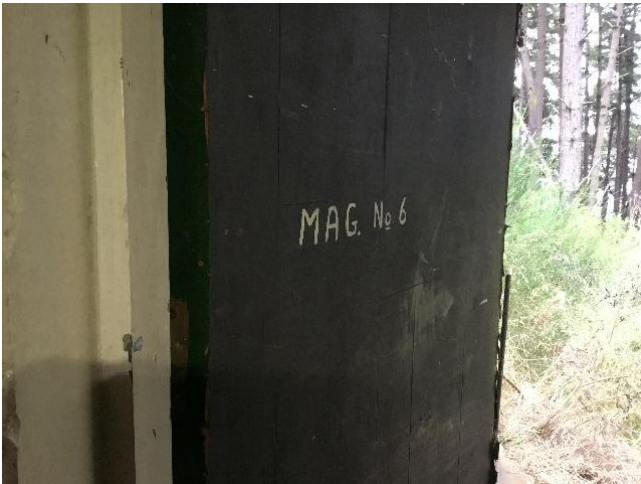
Hazardous Building Materials			
Sample/ Observation	Material Description	Apx Qty m <sup>2</sup>	Analytical Result/Field Observation
A04	Bitumen floor coating	64	Assumed PAHs
A06	Internal doors - paint	6	Assumed lead paint

Sample/Observation Reference: **A06**  
Internal doors grey blue paint  
Assumed lead paint

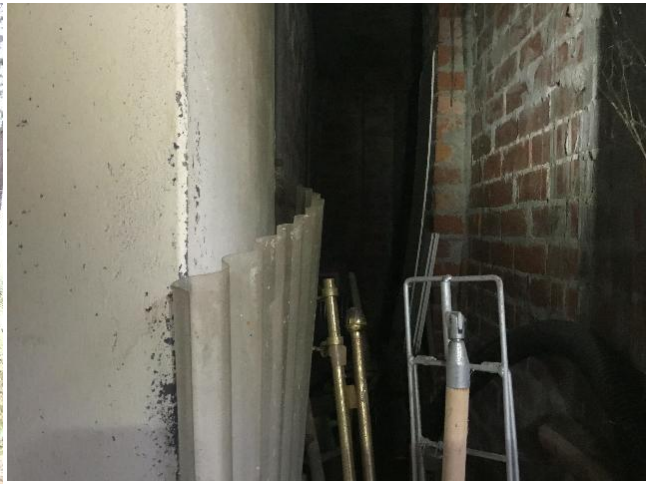
Sample/Observation Reference: **A03**  
Internal wall / external wall (blast cavity)  
**Assumed ACM**

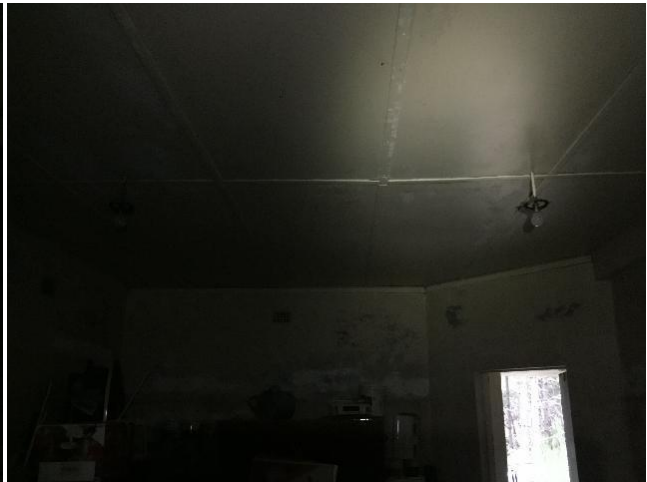
Sample/Observation Reference: **A05**  
**Assumed ACM**  
Ceiling and coving sheet materials

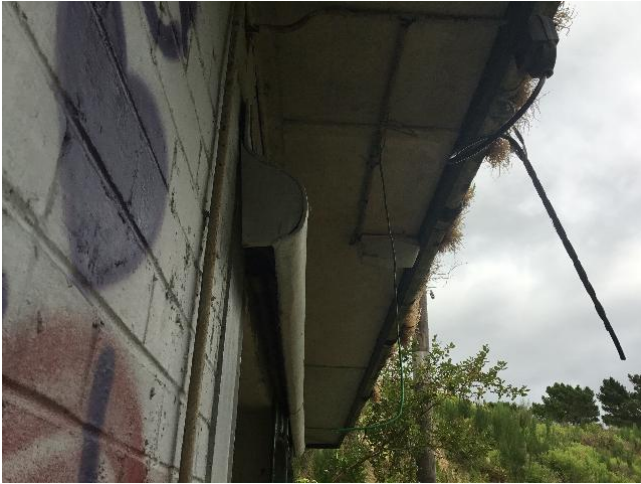
Sample/Observation Reference: **A04**  
Assumed ACM  
Gutters and flashing over door

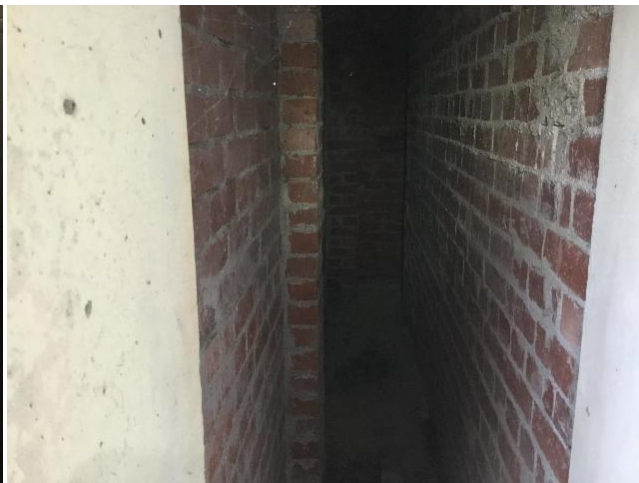
Sample/Observation Reference: **B02 + A07**

Bitumen floor coating

**Chrysotile asbestos** (laboratory result)

Assumed PAHs

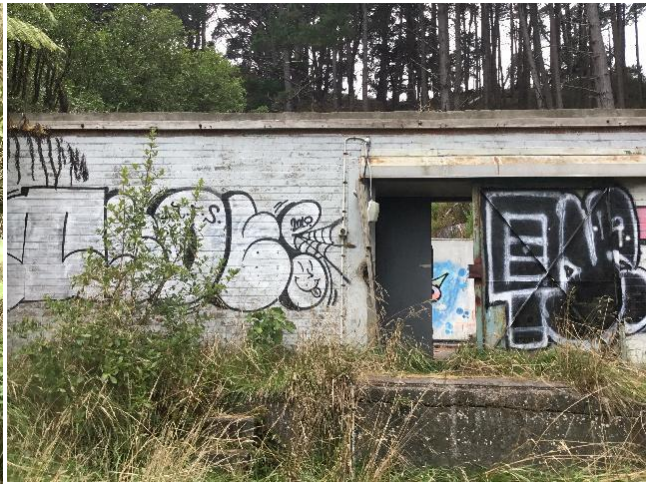
Sample/Observation Reference: **B04**

Exterior paint

0.14 % lead (laboratory result)

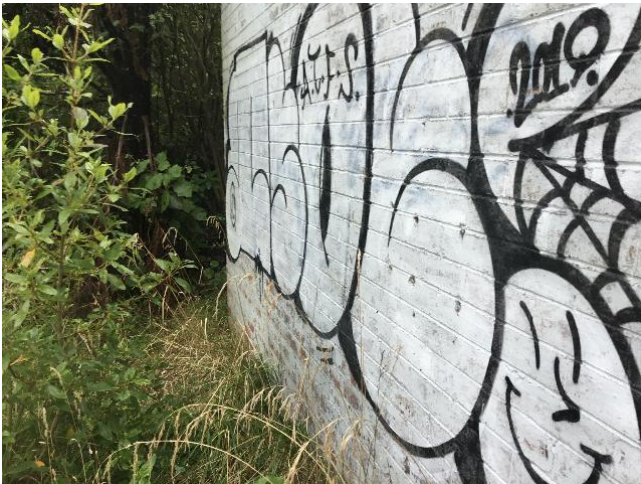
Sample/Observation Reference: **B02 + A02**

**Chrysotile asbestos** (laboratory result)

Assumed PAHs

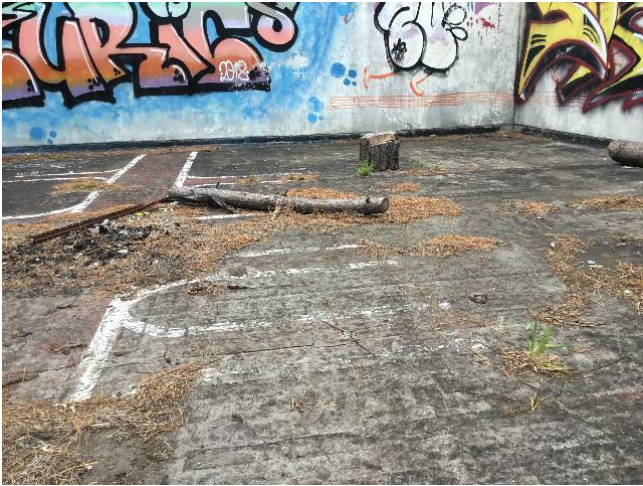
Sample/Observation Reference: **B01**

Black bitumen material

No Asbestos Detected (laboratory result)

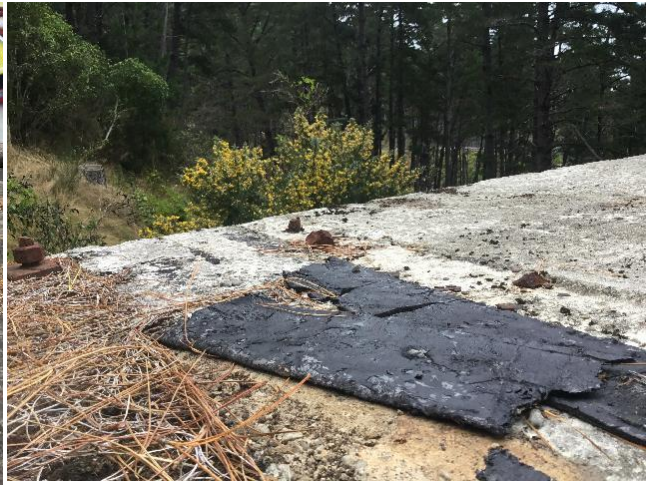
Sample/Observation Reference: **B03**

Internal walls paint

0.11 % lead (laboratory result)

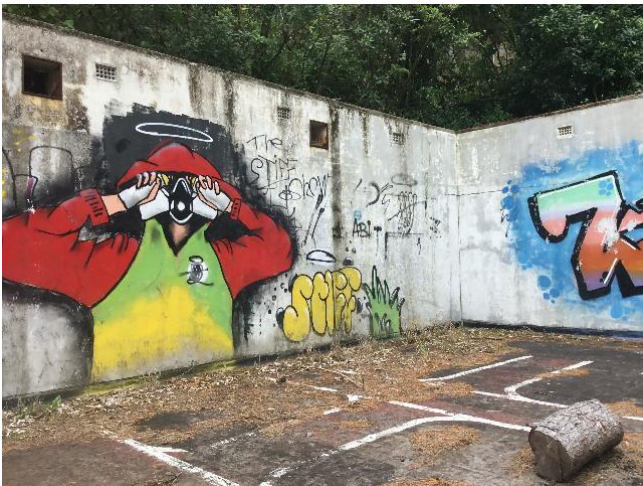
Sample/Observation Reference: **A01**

**Assumed ACM**

Internal wall/external wall (blast cavity)

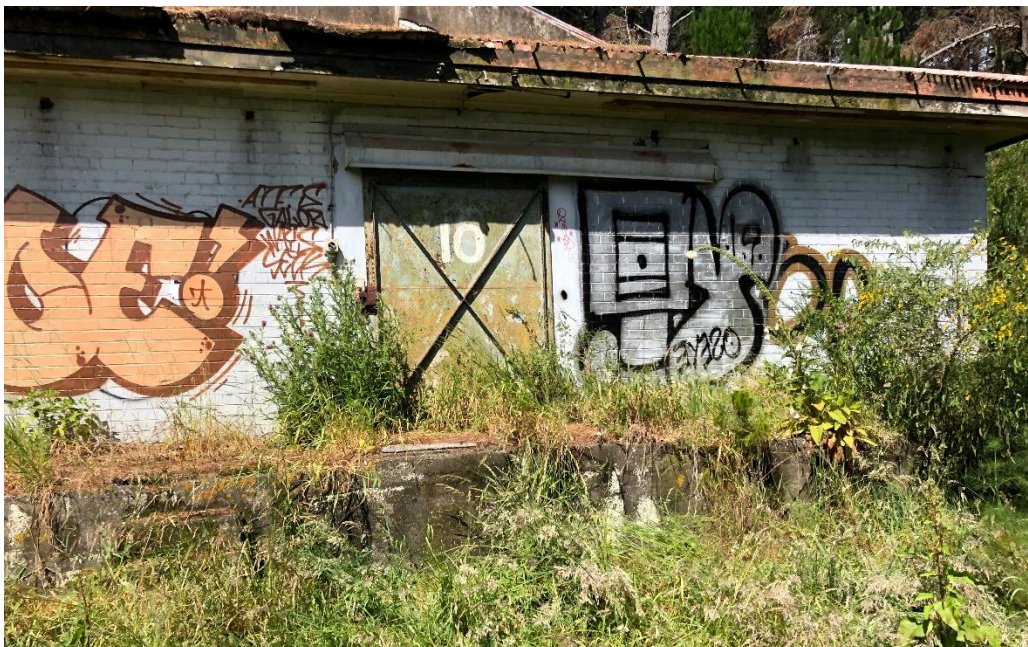
*Magazine No.10.*

On 17 March 2020 and during the survey of other buildings at Watts Peninsula, Magazine No.10 was visited. At this time the door could not be slid open and access within the structure was not possible.

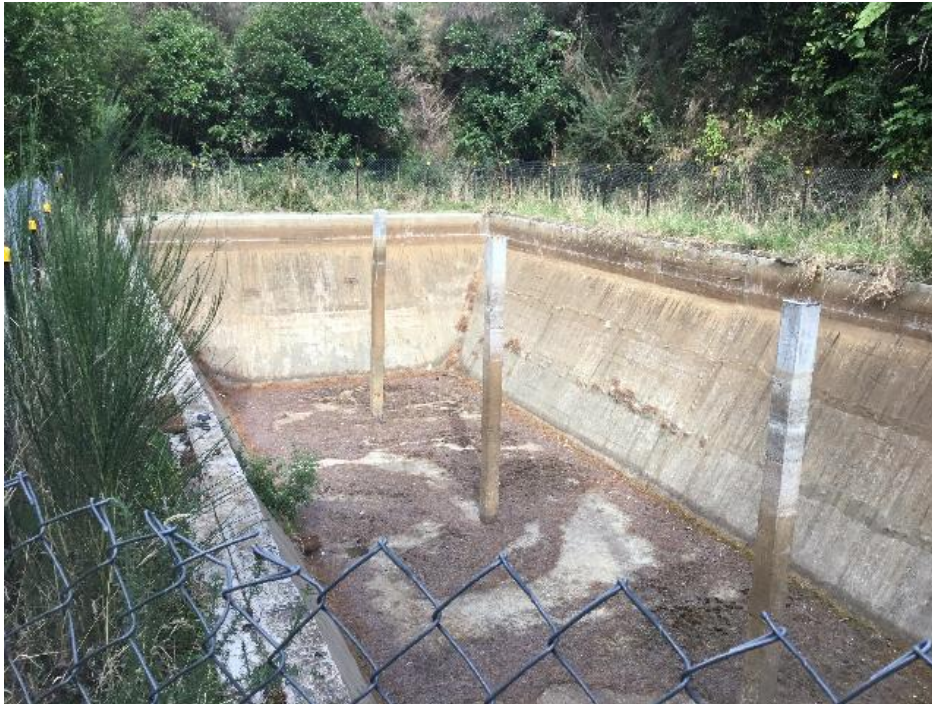
*Reservoir.*

Access to the reservoir was prohibited by secure/high fencing. It comprises a concrete structure with a (beige) coating, possibly bitumen based material.
