# Hazardous Building Materials Survey

Survey Date - 18 March 2020

Watts Peninsula - Farm Buildings

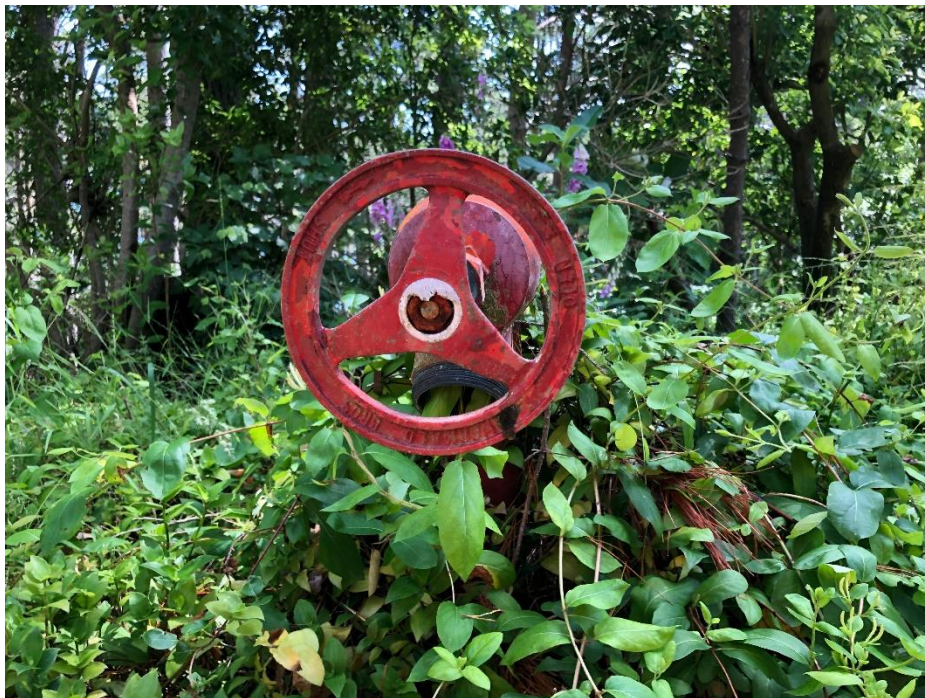
A (firefighting) standpipe/hydrant was observed close to the reservoir at the side of the access road connecting the other structures at the peninsula; see photograph below. It is made with (assumed) steel.

*Standpipe/hydrant.*

Until proven otherwise by sampling/observation the coating at the reservoir and any gaskets and paint associated with the standpipe/hydrant should be considered to be hazardous building materials, principally *asbestos containing materials* (friable asbestos) and lead containing paints.

This applies to all pipework associated with the standpipe/hydrant including other such features not observed or buried.

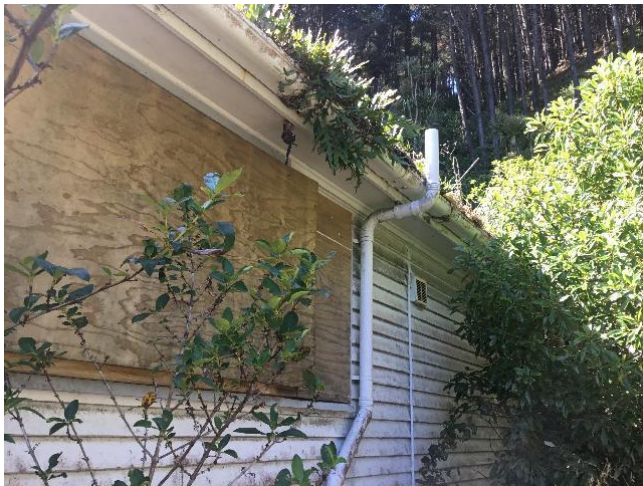
Sample/Observation Reference: **B03**

**Chrysotile asbestos** (laboratory result)

External paint - 7.4 % lead (laboratory result)

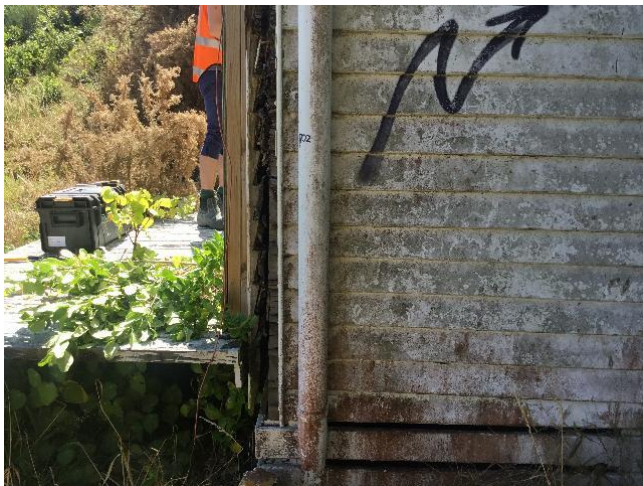
Sample/Observation Reference: **B02**

Down pipe - **Chrysotile asbestos** (laboratory result)

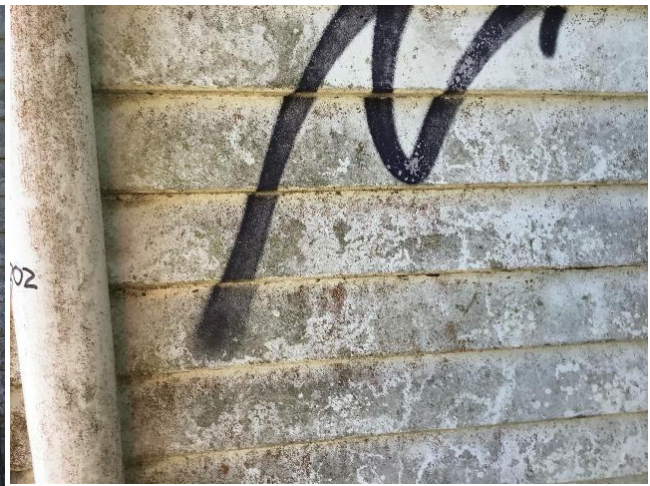
Sample/Observation Reference: **B05**

External paint work – 2.95 % lead (laboratory result)

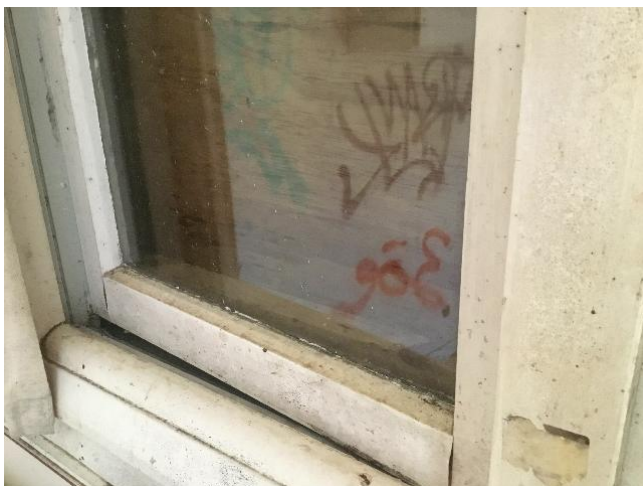
Sample/Observation Reference: **A02**

Assumed ACM

(Not accessible) window putty

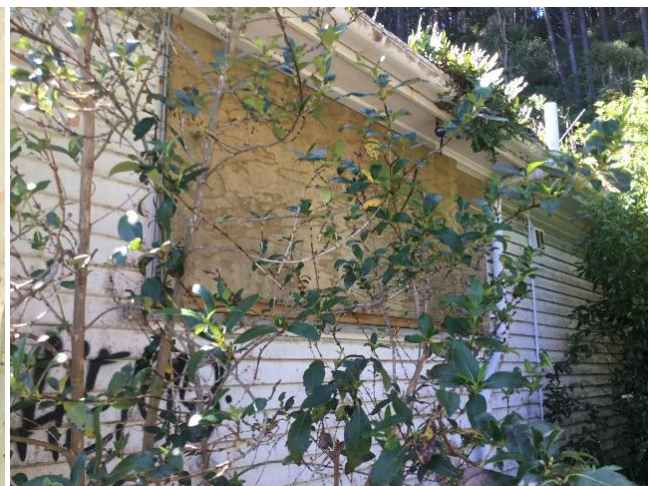
External window putty (covered by security boarding)

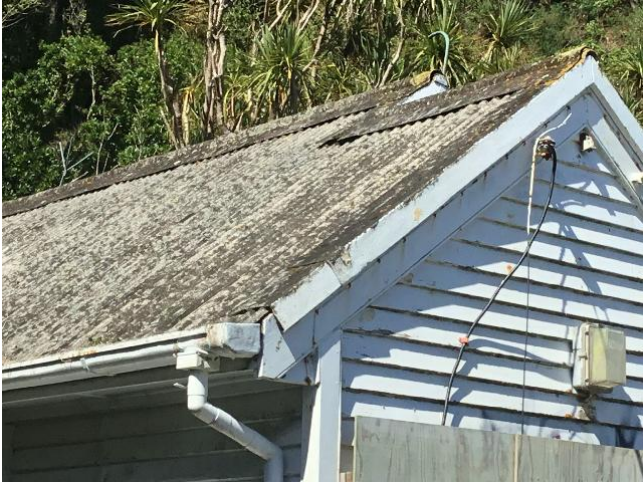
Sample/Observation Reference: **A03**

Assumed ACM

Flashing and roof (above 3 m height)

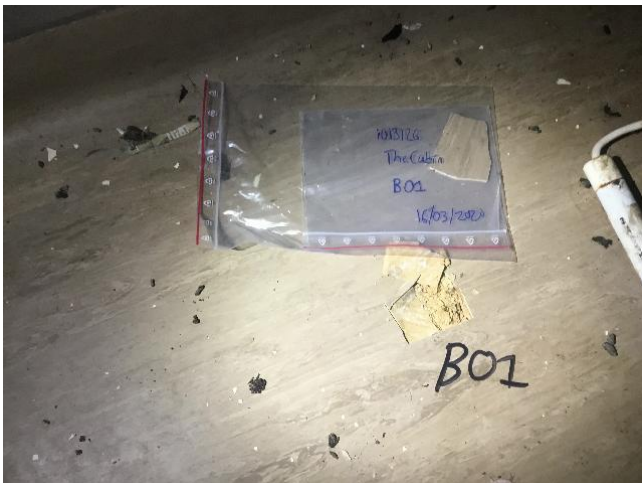
Sample/Observation Reference: **B01**

Bathroom vinyl flooring – brown

No asbestos detected (laboratory result)

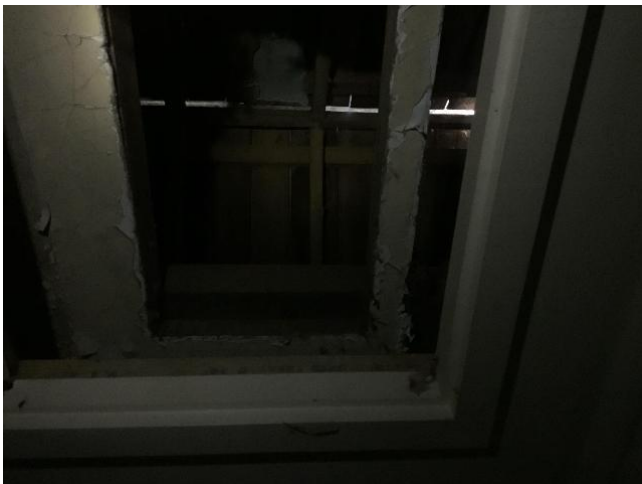
Sample/Observation Reference: **A01**

Assumed ACM

Attic space viewed from loft hatch

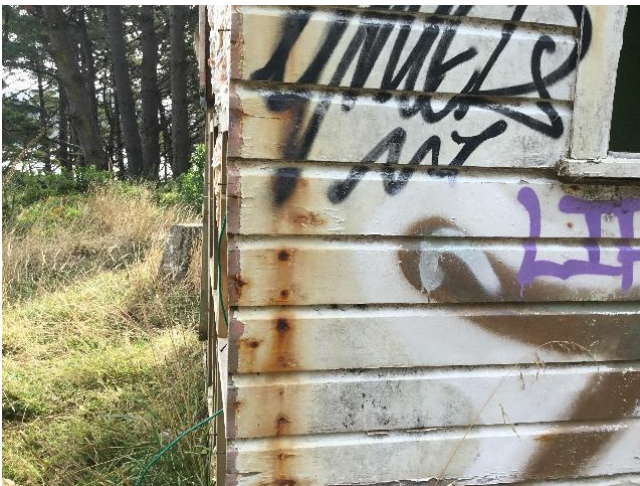
Sample/Observation Reference: **B02**

Exterior paint – 0.24 % lead (laboratory result)

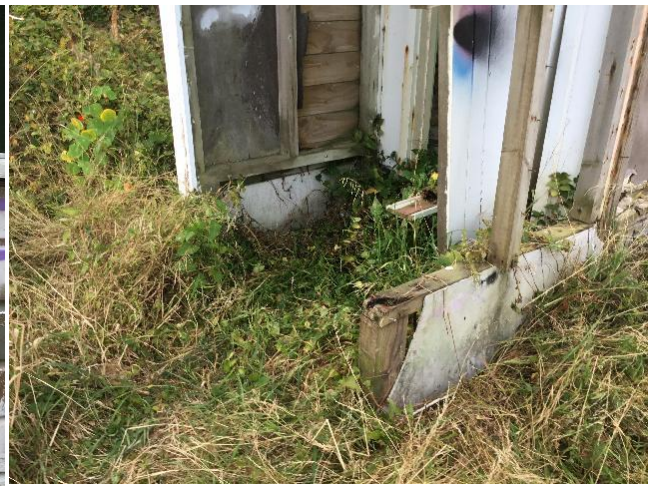
Sample/Observation Reference: **B01**

Cement sheet bottom of porch

No asbestos detected (laboratory result)

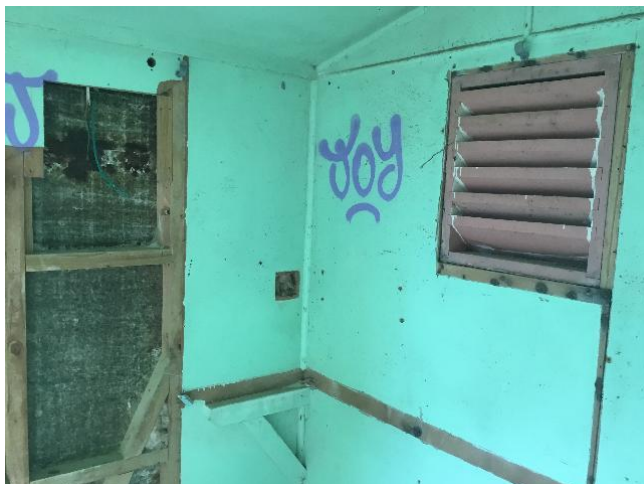
Sample/Observation Reference: **B03**  
Interior paint – 0.51 % lead (laboratory result)

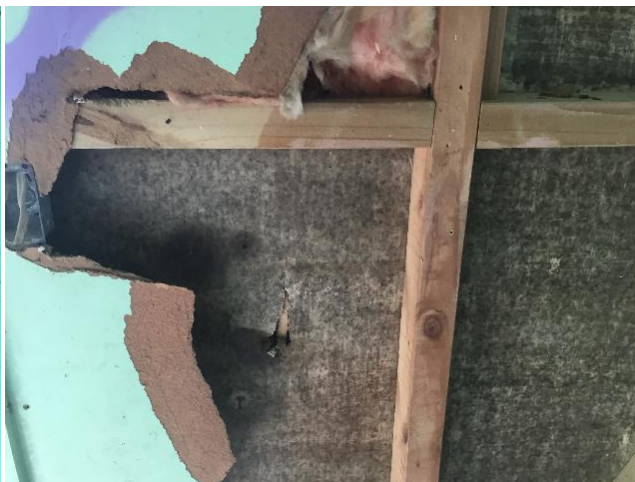
Sample/Observation Reference: **N01**  
No ACM Assumed  
Paper lining (wood fibres)
